UTAH STATE CAPITOL ARCHITECTURE: INTERIOR PRESERVATION ZONE II SURVEY REPORT

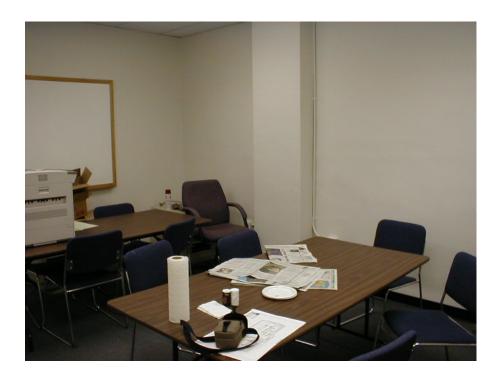
108 State Auditor's 107/109 Lunch Room

Original Use Auditor's vault

Element	Description	Historical Significance	Notes
WN-11	Metal transom, louvered	Non-Contributory Qnty:	
B-1	Gray marble base, 12" polished	Very Significant Qnty:	
B-4	Rubber/vinyl base	Non-Contributory Qnty:	
CL-08	Acoustical ceiling, suspended T-bar frame	Non-Contributory Qnty:	
CPP-7	Plaster pilaster, painted	Significant Qnty:	
D-09	Wood slab door with decorative metal-wood grained casing, transom above	Contributory Qnty:	
D-13	Metal wood-grained panel door with matching casing. Bankers glass panels	Contributory Qnty:	
F-12	Carpeted floor, glue-down	Contributory Qnty:	
H-1	Brass door handle, modern	Contributory Qnty:	
L-08	Fluorescent lights	Non Contributory Qnty:	
M-16	Marble window sill, original, with molded wood skirt	Contributory Qnty:

M-21	Metal casing, new	Non Contributory Qnty:
M-6	Metal wood-grained casing w/ fancy profile	Non-Contributory Qnty:
W-18	demountable wall	Non Contributory Qnty:
W-8	Sheetrock wall, painted and smooth	Contributory Qnty:
WN-1	Aluminum replacement window	Non Contributory Qnty:

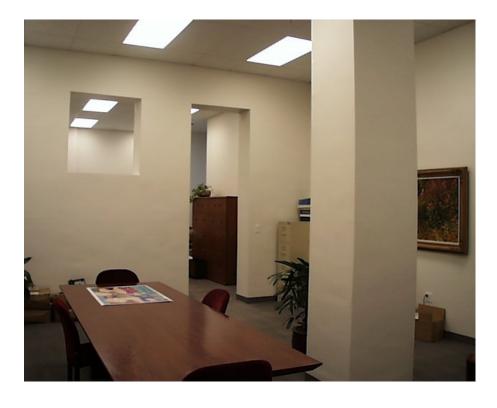
113 Office of the First Lady

Original Use Café walk-in refrigerator

Element	Description	Historical Significance	Notes
B-4	Rubber/vinyl base	Non-Contributory Qnty:	
B-7	Marble base block	Significant Qnty:	
CL-08	Acoustical ceiling, suspended T-bar frame	Non-Contributory Qnty:	
D-09	Wood slab door with decorative metal-wood grained casing, transom above	Contributory Qnty:	with H-1
F-12	Carpeted floor, glue-down	Contributory Qnty:	
L-08	Fluorescent lights	Non-Contributory Qnty:	
W-8	Sheetrock wall, painted and smooth	Contributory Qnty:	the connecting wall with room 111 is not dry wall - may be covered with, but thickness indicates stone - ooalite possibly

Notes connects to room 113 - also called office of the First Lady

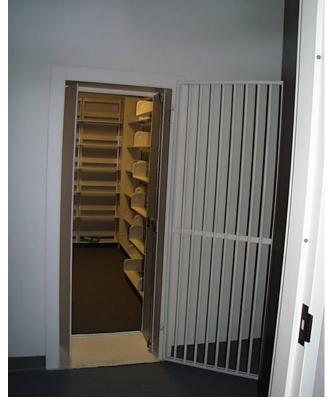
121e vault

Element	Description	Historical Significance	Notes
B-4	Rubber/vinyl base	Non-Contributory Qnty:	
E-12	electrical box	Non-Contributory Qnty:	security
F-12	Carpeted floor, glue-down	Contributory Qnty:	broadloom
MS-3	Fire hose cabinet, glass, metal, recessed in wall	Non-Contributory Qnty: 2	
SP-10	Furniture now NHF	Non-Contributory Qnty:	steelmaster
SP-3	Wood bookcase, built-in	Non-Contributory Qnty:	s
CL-08	Acoustical ceiling, suspended T-bar frame	Non-Contributory Qnty:	in hall area
CL-09	Concrete ceiling	Contributory Qnty:	
D-04	Wood panel door, decorative metal wood- grained casing, transom above	Significant Qnty:	with M-6, painted white and H-3
F-16	Concrete floor, painted	Non-Contributory Qnty:	
L-08	Fluorescent lights	Non-Contributory Qnty:	
W-6	Concrete wall	Non-Contributory Qnty:	
W-8	Sheetrock wall, painted and smooth	Contributory Qnty:	in hall area

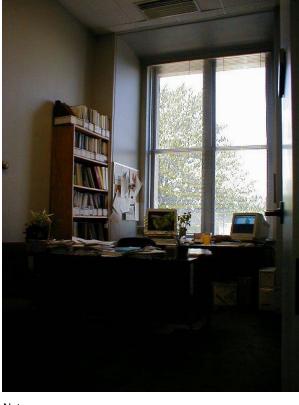
164 G.O.P.B.

Vestibule: Cold air chamber

Element	Description	Historical Significance	Notes
B-1	Gray marble base, 12" polished	Very Significant Qnty:	
B-4	Rubber/vinyl base	Non-Contributory Qnty:	
CL-08	Acoustical ceiling, suspended T-bar frame	Non-Contributory Qnty:	
D-09	Wood slab door with decorative metal-wood grained casing, transom above	Contributory Qnty:	
D-13	Metal wood-grained panel door with matching casing. Bankers glass panels	Contributory Qnty:	
F-12	Carpeted floor, glue-down	Contributory Qnty:	
H-1	Brass door handle, modern	Contributory Qnty:	
L-08	Fluorescent lights	Non Contributory Qnty:	
M-16	Marble window sill, original, with molded wood skirt	Contributory Qnty:	
M-6	Metal wood-grained casing w/ fancy profile	Non-Contributory Qnty:	
W-2	Oolite slab wall, painted	Very Significant Qnty:	
W-7	Plaster wall, painted and smooth	Contributory Qnty:	
WN-1	Aluminum replacement window	Non Contributory Qnty:	
WN-7	Wood transom	Contributory Qnty:

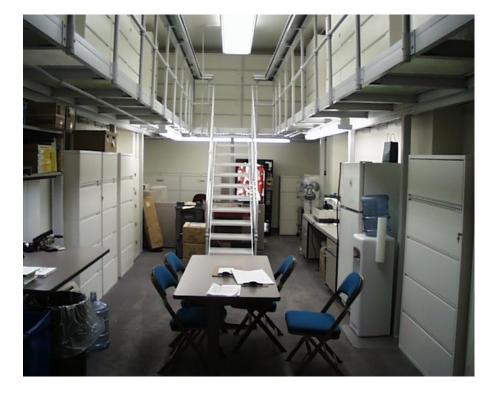
203f Lieutenant Governor - Vault

Original Use Secretary of State

vault

Element	Description	Historical Significance Notes
B-4	Rubber/vinyl base	Non-Contributory Qnty:
CL-04	Plaster ceiling, smooth, flat, painted	Non-Contributory Qnty:
CPP-7	Plaster pilaster, painted	Significant Qnty: 6
F-11	Carpeted floor, on pad	Contributory Qnty:
L-81	Parabolic	Non-Contributory Qnty: 6
SP-17	steel mezzanine, for file storage, with glass floor	Contributory Qnty:
W-7	Plaster wall, painted and smooth	Contributory Qnty:

Notes no vents seen; no door

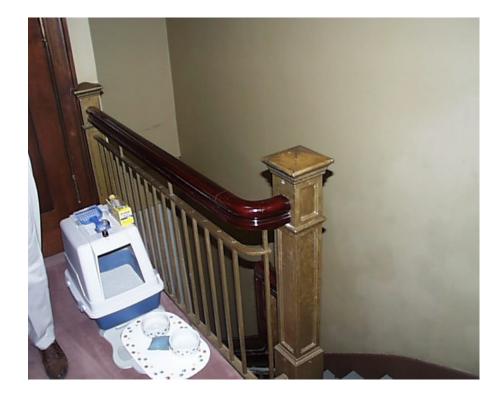
205a **Governor's Private Entry Hall**

Notes includes 205 b - same entry

Element	Description	Historical Significance	Notes
F-21	tile floor - small square	Contributory Qnty:	
P-10	Toilet, Non-original	Contributory Qnty:	
P-13	Porcelain sink	Contributory Qnty:	
B-4	Rubber/vinyl base	Non-Contributory Qnty:	
CL-07	Acoustical tile ceiling, glue-on	Non-Contributory Qnty:	dropped
D-25	Wood panel door with decorative wood casing	Contributory Qnty: 1	faux bois, either side of vestibule/hall. Door to office ha a vent.
F-11	Carpeted floor, on pad	Contributory Qnty:	a voin.
ST-3	wood handrail	Contributory Qnty:	
ST-6	Concrete tread, painted	Contributory Qnty:	
ST-7	Metal post, painted	Contributory Qnty: 3	
ST-8	Metal balustrade, non-ornamental	Contributory Qnty:	
W-14	Wallpapered wall	Non-Contributory Qnty:

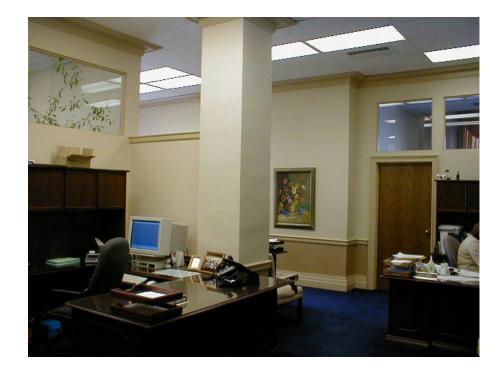
211 **Auditors 207/211**

Original Use Business office

Notes includes 211a,b,d - B used to be restrooms,

Element	Description	Historical Significance	Notes
CL-08	Acoustical ceiling, suspended T-bar frame	Non Contributory Qnty:	
L-08	Fluorescent lights	Non Contributory Qnty:	
M-11	Wood chair rail	Contributory Qnty:	Painted
M-16	Marble window sill, original, with molded wood skirt	Significant Qnty:	
M-19	Wood casing, new	Contributory Qnty:	Painted
W-7	Plaster wall, painted and smooth	Contributory Qnty:	
WN-1	Aluminum replacement window	Non Contributory Qnty:	
WN-6	Interior sidelight window, wood	Non Contributory Qnty:	
D-10	Metal wood-grained panel door with matching casing. Bankers glass panel and transom	Very Significant Qnty:	Double doors, main entry - with marble threshold
D-15	Wood slab door with plain wood casing (simple closet/demountable doors)	Non Contributory Qnty:	
B-2	Molded wood base	Contributory Qnty:	
F-11	Carpeted floor, on pad	Contributory Qnty:	
W-8	Sheetrock wall, painted and smooth	Contributory Qnty:

W-18	demountable wall	Non Contributory Qnty:	Painted
D-23	Wood slab door with decorative wood casing	Non Contributory Qnty:

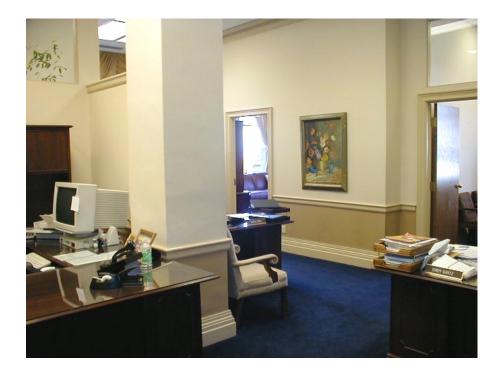
211c **Auditors 207/211**

Auditing/proof reading

Element	Description	Historical Significance	Notes
CL-08	Acoustical ceiling, suspended T-bar frame	Non Contributory Qnty:	
D-11	Metal wood-grained panel door with matching casing. Plain louver transom	Contributory Qnty:	
L-08	Fluorescent lights	Non Contributory Qnty:	
M-11	Wood chair rail	Contributory Qnty:	Painted
M-16	Marble window sill, original, with molded wood skirt	Significant Qnty:	
M -19	Wood casing, new	Contributory Qnty:	Painted
W-18	demountable wall	Non Contributory Qnty:	
W-7	Plaster wall, painted and smooth	Very Significant Qnty:	
WN-1	Aluminum replacement window	Non Contributory Qnty:	
D-23	Wood slab door with decorative wood casing	Contributory Qnty:	
WN-6	Interior sidelight window, wood	Non Contributory Qnty:	
B-2	Molded wood base	Contributory Qnty:	
F-3	Original wood floor: maple	Significant Qnty:	Possibly not historic - but appears to be "real"
W-8	Sheetrock wall, painted and smooth	Contributory Qnty:

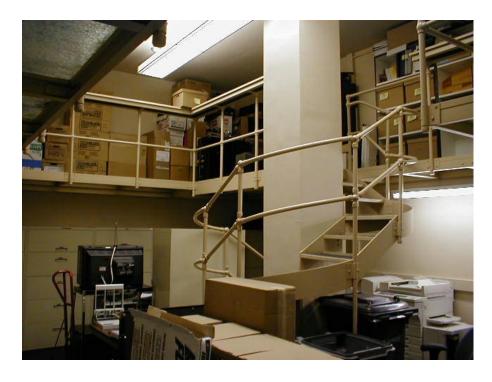
211e **Auditors 207/211**

Original Use vault

Element	Description	Historical Significance	Notes
F-12	Carpeted floor, glue-down	Non Contributory Qnty:	
B-4	Rubber/vinyl base	Non Contributory Qnty:	
M-19	Wood casing, new	Contributory Qnty:	Casing over 1 foot opening - no door.
SP-17	steel mezzanine, for file storage, with glass floor	Non contributory Qnty:	
L-81	Parabolic	Non Contributory Qnty:	
W-7	Plaster wall, painted and smooth	Contributory Qntv:

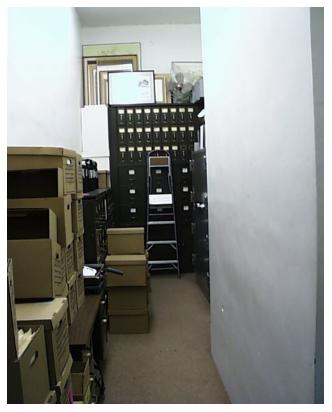
215a **State Treasurer - Office Vault**

Original Use Treasurer's vault

Element	Description	Historical Significance	Notes
CL-09	Concrete ceiling	Very Significant Qnty:	
E-12	electrical box	Non Contributory Qnty:	various
D-13	Metal wood-grained panel door with matching casing. Bankers glass panels	Contributory Qnty:	
CPP-10	Concrete	Contributory Qnty:	
F-12	Carpeted floor, glue-down	Contributory Qnty:	
L-08	Fluorescent lights	Non Contributory Qnty:

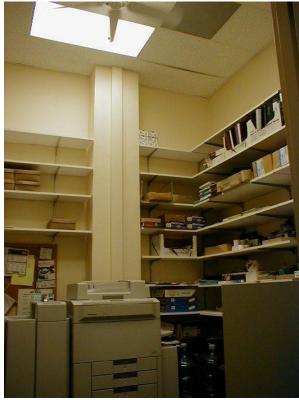
215c **State Treasurer Offices**

Bank Commissioner's

vault

Element	Description	Historical Significance	Notes
E-14	fan	Non Contributory Qnty:	
W-8	Sheetrock wall, painted and smooth	Contributory Qnty:	
W-7	Plaster wall, painted and smooth	Very Significant Qnty:	
B-2	Molded wood base	Contributory Qnty:	
CL-08	Acoustical ceiling, suspended T-bar frame	Non Contributory Qnty:	
CPP-10	Concrete	Contributory Qnty:	
F-12	Carpeted floor, glue-down	Contributory Qnty:	
L-08	Fluorescent lights	Non Contributory Qnty:	
D-15	Wood slab door with plain wood casing (simple closet/demountable doors)	Non Contributory Qnty:	
SP-3	Wood bookcase, built-in	Non Contributory Qnty:

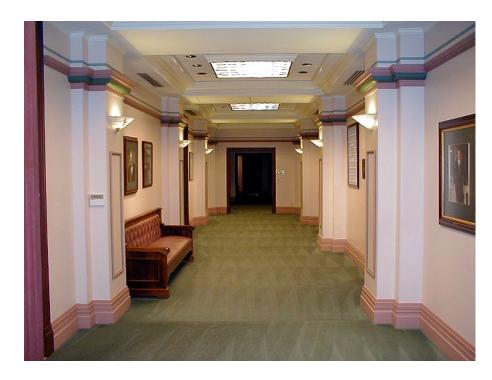
300a **House Hallway**

Original Use House hallway Preservation Level II

Element	Description	Historical Significance	Notes
F-12	Carpeted floor, glue-down	Contributory	Non Original,
		Qnty:	placed in last renovation. Good Condition overall.
W-8	Sheetrock wall, painted and smooth	Contributory	
		Qnty:	
D-11	Metal wood-grained panel door with matching	Contributory	Good
	casing. Plain louver transom	Qnty:	reproduction - possibly with original hardware
CL-08	Acoustical ceiling, suspended T-bar frame	Non Contributory	
		Qnty:	
L-08	Fluorescent lights	Non Contributory	
		Qnty:	
L-14	Recessed lights	Non Contributory	
		Qnty:

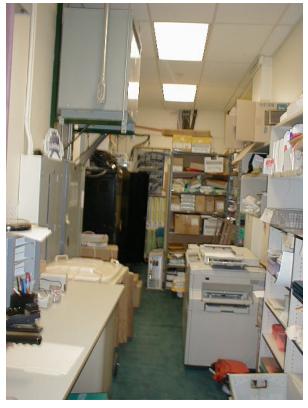
300c **House of Representatives Work Room**

Notes Includes 300b

Element	Description	Historical Significance	Notes
B-4	Rubber/vinyl base	Non-Contributory Qnty:	
CL-08	Acoustical ceiling, suspended T-bar frame	Non-Contributory Qnty:	
D-11	Metal wood-grained panel door with matching casing. Plain louver transom	Contributory Qnty:	
E-12	electrical box	Non-Contributory Qnty:	300b only
F-11	Carpeted floor, on pad	Contributory Qnty:	
HC-10	vent	Non-Contributory Qnty:	300b only
L-08	Fluorescent lights	Non-Contributory Qnty:	
D-01	Wood panel door, decrative wood casing with transom.	Contributory Qnty:	
W-7	Plaster wall, painted and smooth	Non-Contributory Qnty:

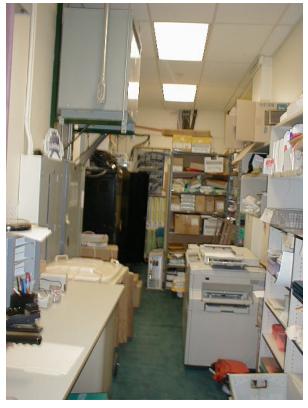
300c **House of Representatives Work Room**

Notes Includes 300b

Element	Description	Historical Significance	Notes
B-4	Rubber/vinyl base	Non-Contributory Qnty:	
CL-08	Acoustical ceiling, suspended T-bar frame	Non-Contributory Qnty:	
D-11	Metal wood-grained panel door with matching casing. Plain louver transom	Contributory Qnty:	
E-12	electrical box	Non-Contributory Qnty:	300b only
F-11	Carpeted floor, on pad	Contributory Qnty:	
HC-10	vent	Non-Contributory Qnty:	300b only
L-08	Fluorescent lights	Non-Contributory Qnty:	
D-01	Wood panel door, decrative wood casing with transom.	Contributory Qnty:	
W-7	Plaster wall, painted and smooth	Non-Contributory Qnty:

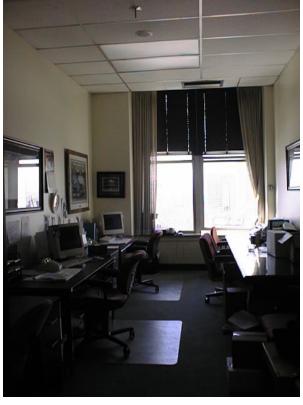
322 **Work Room**

Original Use Committee Room

Notes Includes 324; 326; 328;330.

Element	Description	Historical Significance	Notes
B-4	Rubber/vinyl base	Non-Contributory Qnty:	
B-6	Plaster base, painted	Significant Qnty:	Along plaster wal
CL-08	Acoustical ceiling, suspended T-bar frame	Non-Contributory Qnty:	
D-26	Wood panel door with decorative metal wood- grained casing and decorative metal. Painted louvered transom	Contributory Qnty:	
F-11	Carpeted floor, on pad	Contributory Qnty:	
L-08	Fluorescent lights	Non-Contributory Qnty:	
W-7	Plaster wall, painted and smooth	Contributory Qnty:	
W-8	Sheetrock wall, painted and smooth	Contributory Qnty:	east side
WN-1	Aluminum replacement window	Non-Contributory Qnty:	
WN-11	Metal transom, louvered	Non-Contributory Qnty:	same as 330

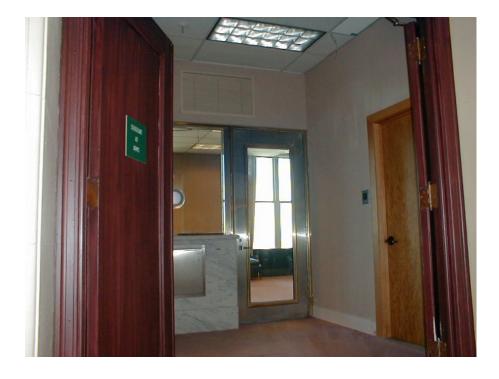
332 **Vacant Offices**

Committee Room

Notes Includes 332b

Element	Description	Historical Significance	Notes
B-6	Plaster base, painted	Very Significant Qnty:	painted
F-11	Carpeted floor, on pad	Contributory Qnty:	
W-11	Fabric wall, glue-on	Non contributory Qnty:	
W-7	Plaster wall, painted and smooth	Very Significant Qnty:	
W-8	Sheetrock wall, painted and smooth	Contributry Qnty:	
CL-07	Acoustical tile ceiling, glue-on	Significant Qnty:	
L-81	Parabolic	Non Contributry Qnty:	
D-05	Metal wood-grained panel door with matching casing	Significant Qnty:	
D-30	Aluminum doors with glass panels and matching transoms. Swing doors to patio in corner offices.	Significant Qnty:	
WN-1	Aluminum replacement window	contributory Qnty:	
D-18	Metal wood-grained panel door with matching casing. Plain louver transom	Very Significant Qnty:	Double Entry door - to cooridoor, into Entry vestibule
WS-2	Marble wainscot, polished	Very Significant Qnty:	Entry vestibule
MS-15	Broadcast station: metal/glass cabinets bolted to floor	Very Significant Qnty:	Entry vestibule

D-08	Wood slab door with decorative metal-wood grained casing	Very Significant Qnty:	Entry vestibule

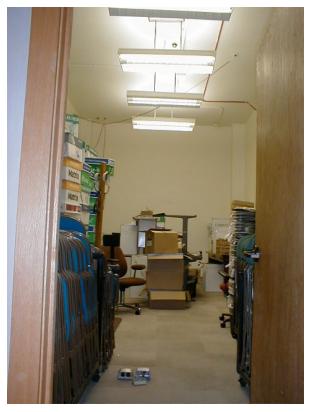
332a **Vacant Offices/ Storage Room**

Original Use Clerk's vault Preservation Level II

Element	Description	Historical Significance	Notes
W-7	Plaster wall, painted and smooth		
		Qnty:	
F-14	Carpet tiles	Ontre	
		Qnty:	
CL-10	Plaster ceiling, molded and decorative	Qnty:	
D-15	Wood slab door with plain wood casing	y .	
D-13	(simple closet/demountable doors)	Qnty:

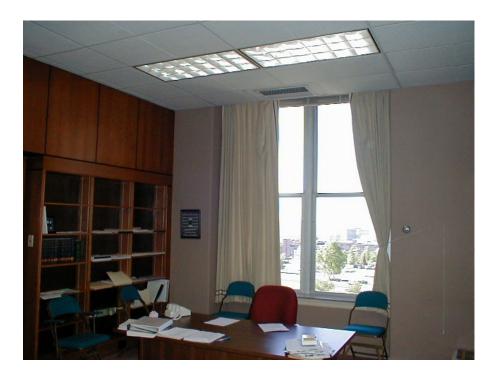
333 **Vacant Offices**

Supreme Court offices Original Use

Element	Description	Historical Significance	Notes
SP-3	Wood bookcase, built-in	Contributory Qnty:	
B-6	Plaster base, painted	Significant Qnty:	
CL-08	Acoustical ceiling, suspended T-bar frame	Non-Contributory Qnty:	
WN-1	Aluminum replacement window	Non Contributory Qnty:	
L-81	Parabolic	Non Contributory Qnty:	
F-12	Carpeted floor, glue-down	Contributory Qnty:	
D-17	Wood panel door with decorative metal wood-grained casing. Glass transom	Significant Qnty:	
D-07	Wood Panel door with decorative metal wood-grained casing	Contributory Qnty:

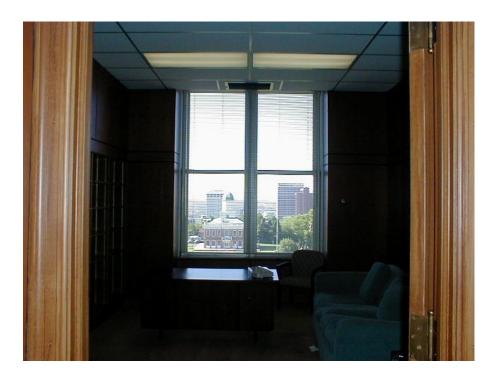
334 **Vacant Offices**

Supreme Court offices

Element	Description	Historical Significance	Notes
W-4	Wood panelled wall	Contributory Qnty:	
B-2	Molded wood base	Contributory Qnty:	
SP-3	Wood bookcase, built-in	Non Contributory Qnty:	
D-21	Metal wood-grained panel door with matching casing. Banker glass panels in door. Plain louver transom	Significant Qnty:	all but room 334 has door 18
CL-08	Acoustical ceiling, suspended T-bar frame	Non-Contributory Qnty:	
D-02	Wood panel door, wood bollection molding casing	Contributory Qnty:	Adjoining office door
D-15	Wood slab door with plain wood casing (simple closet/demountable doors)	Significant Qnty:	Closet
D-11	Metal wood-grained panel door with matching casing. Plain louver transom	Contributory Qnty:	Main Entrance
F-12	Carpeted floor, glue-down	Contributory Qnty:	
L-08	Fluorescent lights	Non Contributory Qnty:	
WN-1	Aluminum replacement window	Non Contributory Qnty:

Notes Includes 336; 338; 340; 342; 342a; 348; 350; 350a & 346

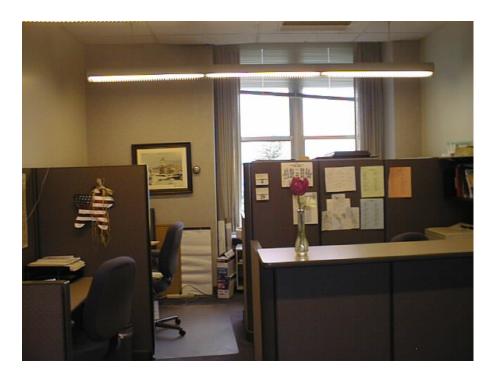
372a **Minority Party leader & Assistant Minority Whip**

Original Use Senate Secretary

Element	Description	Historical Significance	Notes
W-7	Plaster wall, painted and smooth	Very Significant Qnty:	
D-02	Wood panel door, wood bollection molding casing	Significant Qnty:	entrance door between room and 372, marble base block/
D-13	Metal wood-grained panel door with matching casing. Bankers glass panels	Very Significanct Qnty:	marble Threshold
B-2	Molded wood base	Contributory Qnty:	
CL-08	Acoustical ceiling, suspended T-bar frame	Non Contributory Qnty:	
D-05	Metal wood-grained panel door with matching casing	Contributory Qnty: 1	with M-6, B-7, H-3 to hall
F-12	Carpeted floor, glue-down	Contributory Qnty:	
L-82	Pendent Parabolic	Non Contributory Qnty:	
W-11	Fabric wall, glue-on	Contributory Qnty:	Covering East and West walls & Column
W-8	Sheetrock wall, painted and smooth	Contributory Qnty:	
WN-1	Aluminum replacement window	Non Contributory Qnty: 1 pr	with M-16

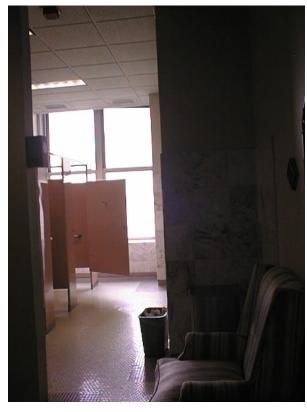
380a **Men's Restroom North - 3rd Floor**

Element	Description	Historical Significance	Notes
D-09	Wood slab door with decorative metal-wood grained casing, transom above	Contributory Qnty:	
CL-08	Acoustical ceiling, suspended T-bar frame	Non-Contributory Qnty:	
B-1	Gray marble base, 12" polished	Very Significant Qnty:	
M-16	Marble window sill, original, with molded wood skirt	Contributory Qnty:	
M-6	Metal wood-grained casing w/ fancy profile	Non-Contributory Qnty:	
P-10	Toilet, Non-original	Non-Contributory Qnty:	
P-12	Urinal, Non-original	Non-Contributory Qnty:	
P-13	Porcelain sink	Non-Contributory Qnty:	
H-1	Brass door handle, modern	Contributory Qnty:	
W-13	Wallpapered wall, bookcloth/burlap	Contributory Qnty:	
E-14	fan	Non Contributory Qnty:	
F-2	Tile floor, hex & square, mosaic	Significant Qnty:	
H-3	Brass door handle, old or original	Contributory Qnty:	
HC-6	Thermostat	Non Contributory Qnty:	
L-08	Fluorescent lights	Non Contributory Qnty:

W-16	Toilet partition/compartment	Non Contributory Qnty:
W-19	white onyx travertine wall	Very Significant Qnty:
WN-1	Aluminum replacement window	Non Contributory Qnty:
W-8	Sheetrock wall, painted and smooth	Contributory Qnty:
WN-3	Interior transom	Contributory Qnty:

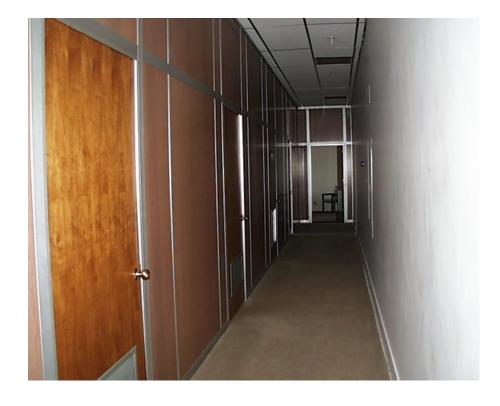
412

Original Use hallway

Notes Includes 412a-f, There are various electric boxes throughout the offices.

Element	Description	Historical Significance	Notes
B-6	Plaster base, painted	Very Significant Qnty:	
B-2	Molded wood base	Contributory Qnty:	
CL-08	Acoustical ceiling, suspended T-bar frame	Non-Contributory Qnty:	
D-07	Wood Panel door with decorative metal wood-grained casing	Contributory Qnty:	possibly original
D-19	Wood slab door with plain metal casing. (demountable wall doors)	Contributory Qnty:	to closet area
F-14	Carpet tiles	Non-Contributory Qnty:	
L-08	Fluorescent lights	Non-Contributory Qnty:	
W-14	Wallpapered wall	Non-Contributory Qnty:	vinyl wall covering
W-18	demountable wall	Non Contributory Qnty:	used as division walls, except at the storage room
W-7	Plaster wall, painted and smooth	Contributory Qnty:	all perameter walls and storage area
W-8	Sheetrock wall, painted and smooth	Contributory Qnty:	storage area division. And most east wall
WN-1	Aluminum replacement window	Non-Contributory Qnty:	Succ Hall

WN-11	Metal transom, louvered	Significant Qnty:	above entry door only

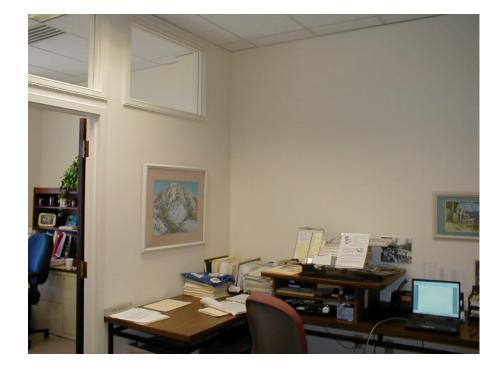
424 Office/ Legislative Research

Notes This description includes 424a, 426 and 426a which were accountancy offices.

Element	Description	Historical Significance	Notes
D-19	Wood slab door with plain metal casing. (demountable wall doors)	Qnty:	
F-11	Carpeted floor, on pad	Contributory Qnty:	
M-6	Metal wood-grained casing w/ fancy profile	Non-Contributory Qnty:	
WN-3	Interior transom	Contributory Qnty:	
B-4	Rubber/vinyl base	Non-Contributory Qnty:	
B-6	Plaster base, painted	Contributory Qnty:	
CL-08	Acoustical ceiling, suspended T-bar frame	Non-Contributory Qnty:	
D-04	Wood panel door, decorative metal wood- grained casing, transom above	Contributory Qnty:	
L-08	Fluorescent lights	Non Contributory Qnty:	
W-7	Plaster wall, painted and smooth	Contributory Qnty:	
W-8	Sheetrock wall, painted and smooth	Contributory Qnty:	
WN-1	Aluminum replacement window	Non Contributory Qnty:	Along exterior wa
D-09	Wood slab door with decorative metal-wood grained casing, transom above	Contributory Qnty:	
M-16	Marble window sill, original, with molded wood skirt	Contributory Qnty:
